Numerical analysis of historical constructions

The paper addresses the scope of numerical analysis of ancient masonry structures. The numerical modelling intends to assess the stability conditions of the salient elements of the façade of the Cathedral of Porto dated from the middle of 12th century. Although no important visible cracking is present, the deep decay of the granite stone and corrosion of steel bars that connect the stone pieces can induce stability problems of the local salient elements of the façade. The numerical modelling is performed with the help of a commercial finite element software program DIANA.

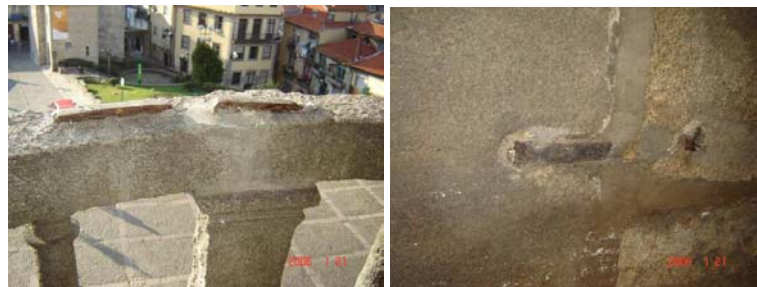
The balcony substructure consists of an almost semi-circular slab, made of granite ashlar that seem to be bounded together with iron dowels. The slab is stiffened by three ribs of the same granite, a central one and two marginal. The loads that are considered to be applied in the balcony include the own weight and the massive granite balustrade at the top of seven granite columns that also seem to integrate steel dowels, see Figure 2.

Figure 2. Details of the connection of the stones in the balcony's balustrade and between the ashlars of the slab

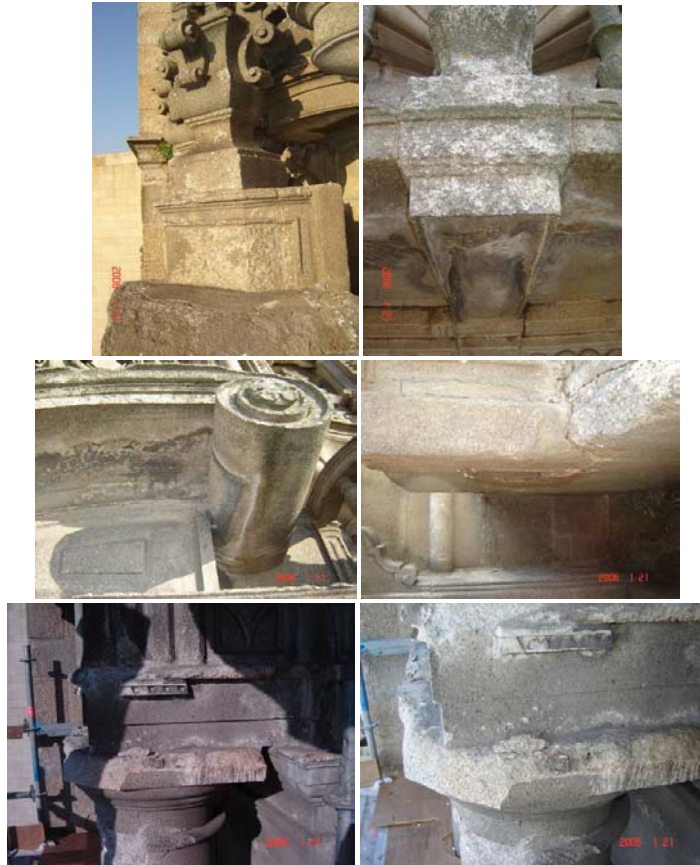
Even if no important cracking is observed on these elements, granite presents signs of weathering, which may result from combined action of cyclic variations of the moisture content, salts (considering also that the cathedral is situated close to the Douro river) and pollution.

As is shown in Figure 3, besides the grey spots on the surface of granite, superficial breaking off is also visible, which can be associated to some physical and chemical actions, leading to high porosity and consequently to the lowering of the mechanical parameters.

Figure 3. Deterioration of the granite – details in the slab, pinnacles and columns

Even so, considering the deep degradation of the granite, it is recommended a surface treatment of the stone, consisting in cleaning the superficial layer and water-proofing the granite surface, so that the polluting factors not to have access to the structure of the stone.

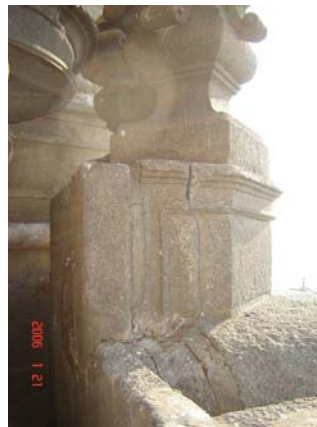
It is probable that the pinnacles' stone ashlars were connected to the battlement by mortar joints and iron dowels. However, a detachment of the pinnacles from the battlement is observed and can be attributed to deterioration of the mortar joints and corrosion of the steel bars. This can affect the deformation of the structure occurs and, thus, must necessarily be considered on the geometric model of the structure in terms of proper boundary conditions, see Figure 4.

Figure 4. Detail of the detaching of pinnacles' structure from the battlement and view of the iron dowels on the back of the elements connecting the granite ashlars

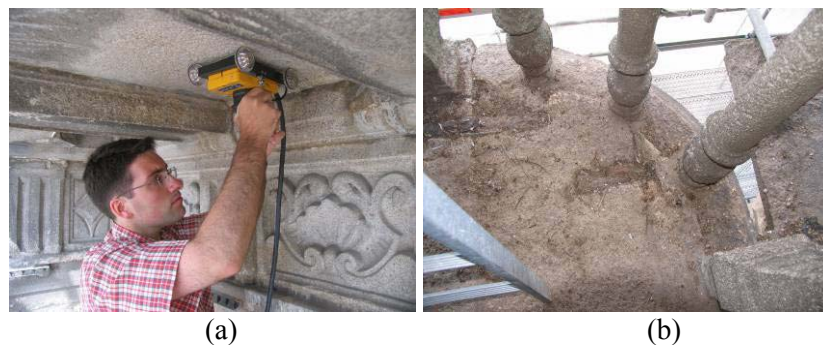
Generally, relative short radar profiles were obtained due to the small dimensions of the testing places. The balcony is composed of overlapped stone ashlar, fixed to the wall and supported, in the inferior part by stone ribs that seem to be connected with metallic dowels. The metallic connectors that may be seen in the surface of the balcony remained uncovered due to the corrosion leading to the disintegration of the stone covering layer. The objective was also to detect the steel connectors (visible or not) that existed in the elements. The lateral battlements were also investigated; see Figure 5 and Figure 6.

Figure 5. Central balcony: (a) inferior ribs of the slab, (b) steel connectors in the balcony's slab

On the top surface of the balcony various radar longitudinal (parallel to the façade) and transversal profiles (perpendicular to the façade) were performed. It was observed that the ashlar are not connected to the wall by steel connectors. The unique steel connectors detected were the ones visible on the balcony's surface.

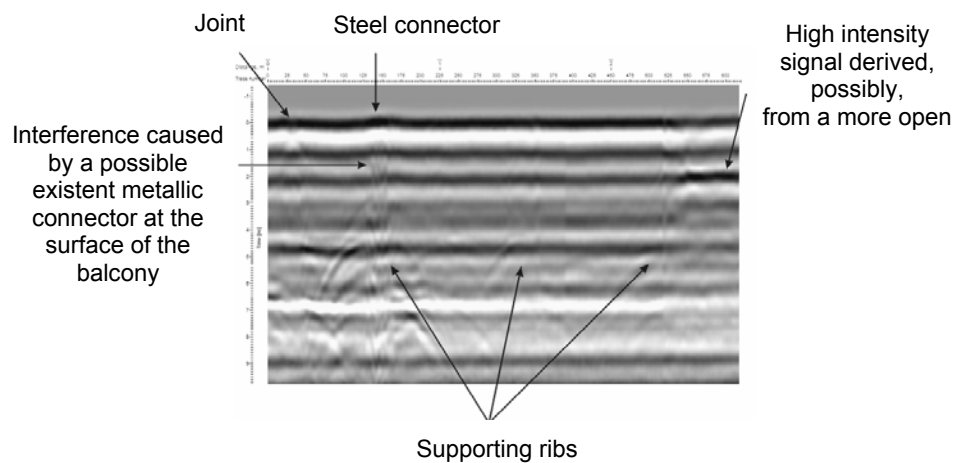
The most relevant results of the inspection may be seen in the Figure 7, where the radargram of the longitudinal profile of the slab is shown. In this profile, the ribs that support the base of the balcony are visible as reference hyperboles. The

average propagation velocity was about 11.5 cm/ns, which is the usual value for the granite stone. No signs of cracking or any other deterioration were detected.

Figure 7. Longitudinal radar profile at 15 cm from the facade's wall

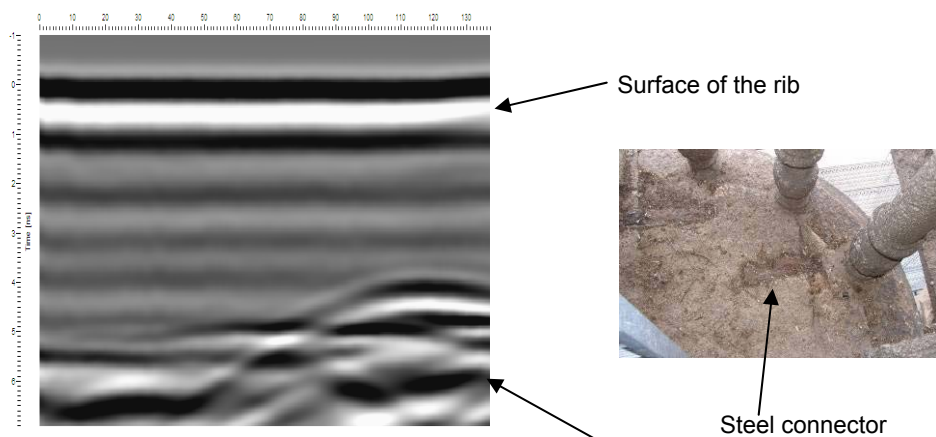
On the bottom surface of the balcony some transversal profiles over and between the ribs were performed. The results obtained in the profiles over the ribs are shown in Figures 8, 9. From both profiles, it is possible to observe the thickness of the ashlars and the position of the steel connectors on the opposite surface (that corresponds to the top surface of the balcony). It is also possible to verify the presence of steel connectors in a depth of around 3 to 6 cm from the top.

Figure 8. Radar profile on the left supporting rib

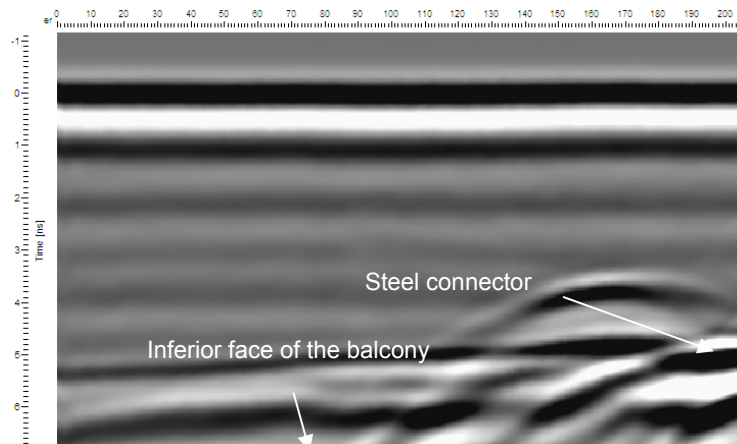
Figure 9. Radar profile of the middle supporting rib

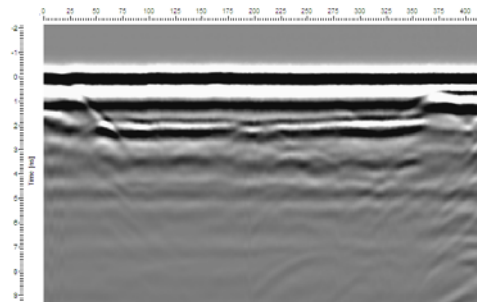
In the left side battlement four tests (two horizontal and other two vertical) were performed. The existence of two steel salient elements that connect two granite independent ashlar made impossible the radar inspection in that respective influence area. Even so, neither deficiency nor steel connectors were detected in this zone, see Figures 10, 11.

Figure 10. Horizontal radar profile

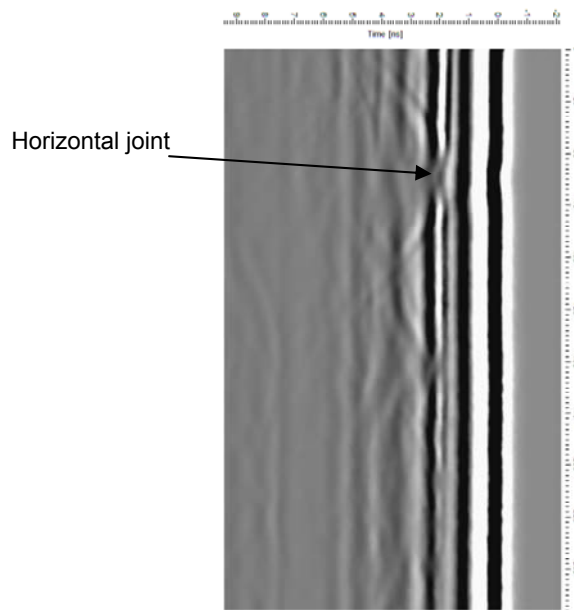
Figure 11. Vertical radar profile

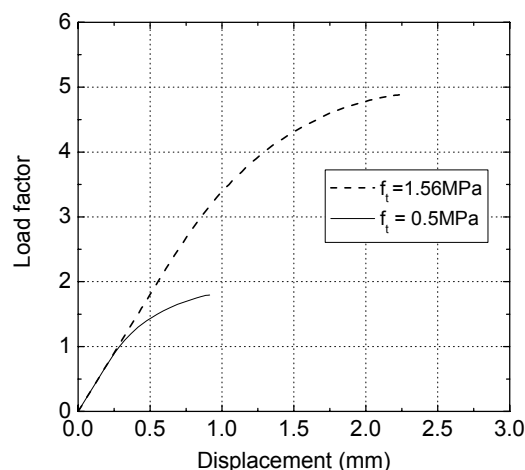
The relation between the load factor and the maximum vertical displacement obtained at the border of the balcony is shown in Figure 26. The onset of the nonlinear behaviour occurs for a load factor of about 1.8, being the cracking localized in the upper edge of the support's section, see Figure 27 and Figure 28, where the principal stress and strain distributions associated to cracking are displayed. For the tensile strength of granite, the load factor is 4.8. This factor represents the scalar that multiplies the gravity load, indicating the safety level of the structure. Note also that the vertical displacement (2.5mm) is rather reduced. This state corresponds to tensile and compressive maximum stresses of respectively 2.79 and 14.6 MPa. It is important to stress that the compressive stress obtained in the nonlinear analysis is clearly below the compressive strength adopted for the granite, which means that the linear model under compression is valid, see Figure 29. Given the weathered state of the granite, an additional nonlinear analysis was performed considering a tensile strength of granite of about 0.5MPa and a fracture energy of about 0.078N/mm, (corresponding approximately to safety partial coefficient for the material γ_M of 3.0). As expected, the initial behaviour is similar but a considerably lower load factor of 1.8 is obtained, see Figure 26. This means that considering 1/3 of the tensile strength, a load factor 80% higher than the own weight is still achieved. For this situation, the maximum values of the tensile and compressive stress are respectively 0.85MPa and 5.33 MPa.

Figure 26. Relation between the load factor and the displacement at the free edge of the balcony

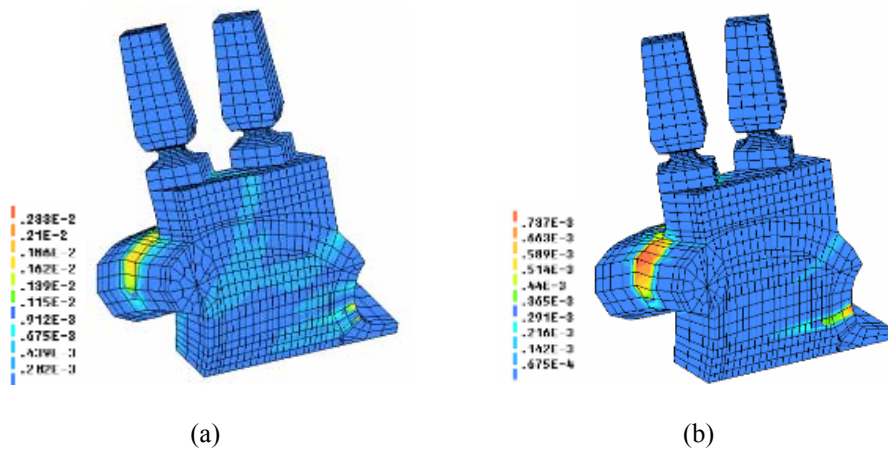
The nonlinear behaviour of the structure for a tensile strength of 0.5MPa is more evident, which is attributed to some cracking presented by the structure, see Figure 32a. Aiming at evaluating the collapse mode, a nonlinear analysis was carried out taking into account a tensile strength of 0.15MPa. It can be seen that the collapse of the structure occurs in the zone of separation between the support and the

decoration of the pinnacles after the crack opening at the right lower corner of the support, see Figure 32b.

Figure 32 – Plastic strains for the last load increment: (a) $f_t=0.5\text{MPa}$; (b) $f_t=0.15\text{MPa}$

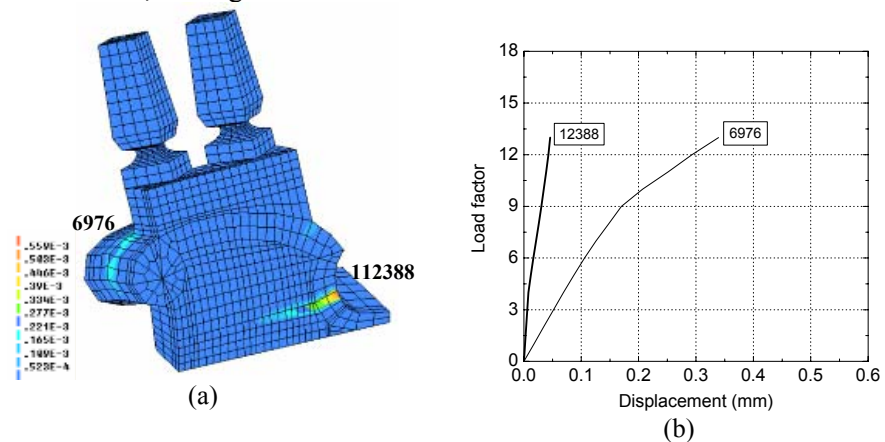
In the collapse mode the cracking initiates in the right lower corner. As the load factor increases, the crack at the lower corner stabilizes and there is crack propagation between the support decoration of the pinnacles and the lower support. This collapse mechanism can also be observed through the comparison of the force-vertical displacement diagrams from different points located in the crack zones. The displacement of node 12388 exhibits a much more slow increase than the node 6976, see Figure 33.

Figure 33 – Analysis of results of pinnacles for a tensile strength of 0.15MPa: (a) plastic strain distribution and control nodes (load factor 10) (b) comparison of force-displacement diagrams for the different cracked zones of the structure

It is important to stress that even for a much low tensile strength, the load factor is considerably high (higher than 13.0). This allows concluding about the safety of the structure even if the granite presents high levels of deterioration.
