Robot helps us to rehabilitate an Over Pass in Resita

Summary

In the winter of 2007 an over gauged transport has heavily hit the three monolith reinforced concrete girders of the superstructure.

The paper presents the damages of the superstructure and also the rehabilitation solutions, which involve the adjustment of the geometry of the under passing junction arm as well.

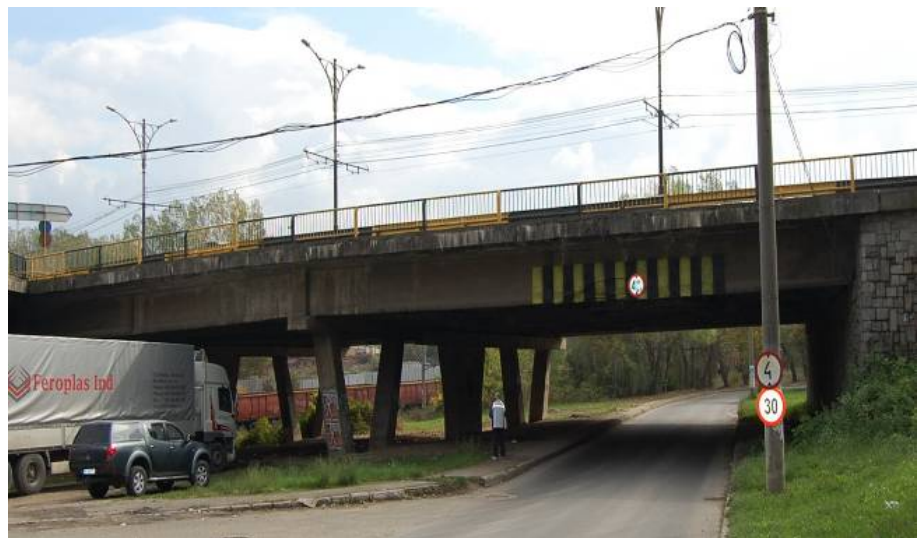
Figure 1. Lateral view towards the first hit beam

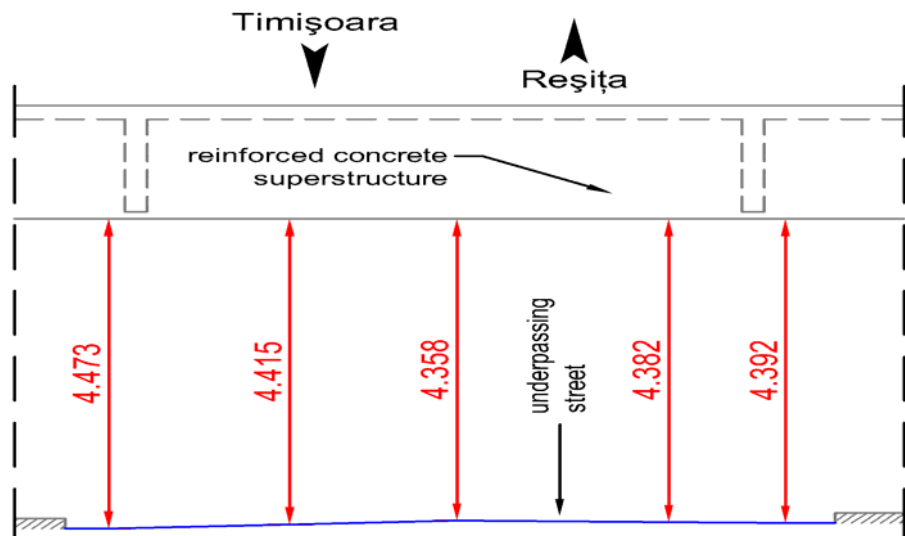
It has to be pointed out that the inferior gauge of the over pass is only 4,20 m, fact that is against the effective standards, which foresee a high of 5,00 m. In this situation accidents, which could affect the integrity of the over pass structure, can occur.

Figure 2. The vertical gauge under the first hit beam

It is notable that from chronologically point of view, the impact occurred as follows: beam 1, beam 2, beam 3 [1]. Thus first was beam 1 hit having the minimum vertical gauge 4,358 m, with 0,158 m higher than the restriction height of 4,200 m (Fig. 2).

The works will be finished by modifying the geometry of the under passing street aiming to provide an appropriate vertical gauge (Fig. 12).

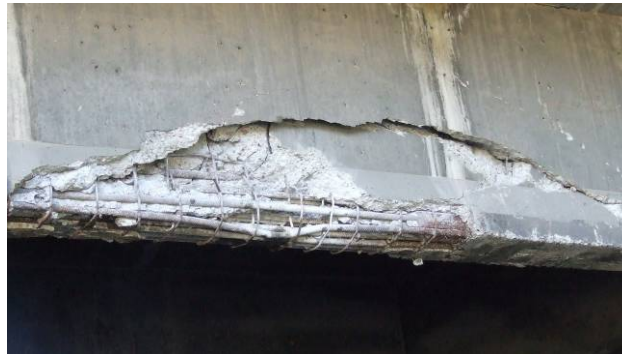
Figure 3. Beam 1

The girders of the span on the abutment side show important degradations of the concrete in the core and the flanges, respectively of the resistance reinforcement, with disrupted and deformed bars, some of these having a seriously diminished section (Fig. 3, 4 and 5).

Due to this degradations, on about 40% of the reinforcement can not be counted anymore, fact that leads to a proportional diminishing of the bearing capacity of the over pass. It was estimated that the reserve of bearing capacity is satisfactory only for vehicles with a maximum load of 3,5 t. Therefore a tonage restriction was imposed in order to keep the traffic for light vehicles.

After the renewal of the degraded reinforcement, the core and the flange of each girder will be reconcreted.

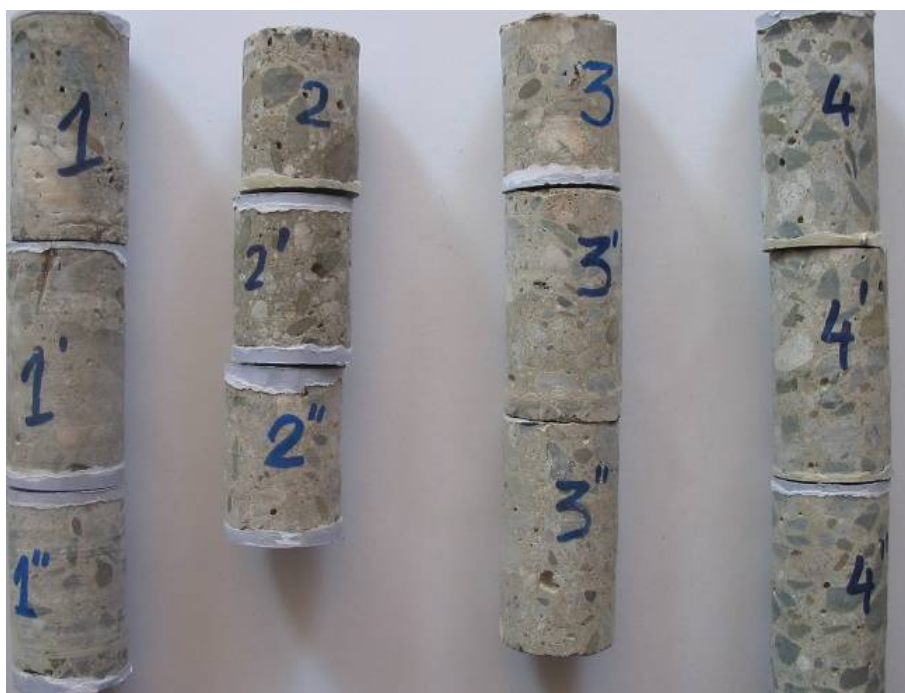
Considering the fact that the replacing solution would mean intervention works at the bearing areas, which would had to be adapted to the designed cross section, and also the alteration of the intermediate pier beam (a highly complex operation), the option was to bring the structure to an adequate bearing capacity. This solution is advantageous as structural concrete is of good quality, C25/30 [2] (Fig. 6).

Figure 6. Concrete test rods from the superstructure

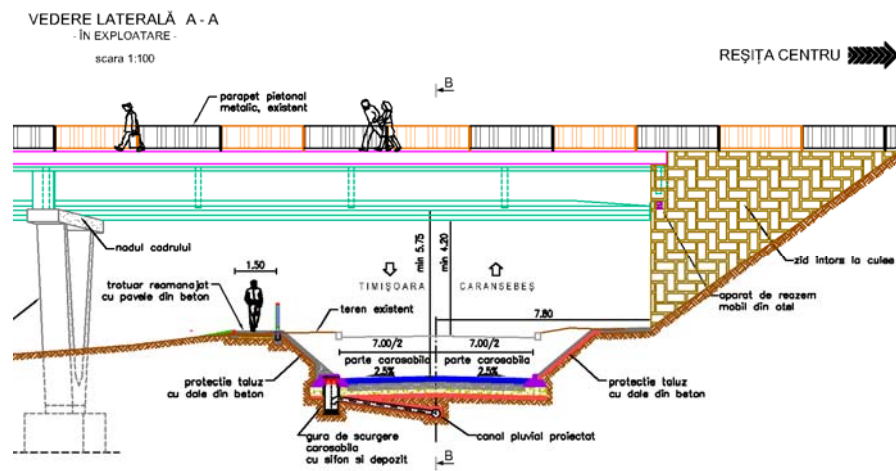
Figure 12. The designed under passing street

Works for the renewal of the sewage respectively for the street lighting will also be executed [3].
