## Analysis of efforts state from bridge decks with hinged beams when the hinges are blocked

*For the construction of bridge superstructures, especially of road bridges, have been used widely beams with hinges (Gerber girders). Due to some design deficiencies in the hinges area, after a 40-50 years operating period, these beams had to be rehabilitated. In most cases the rehabilitation meant their transformation into continuous beams, thus modifying the efforts state from the structure.*

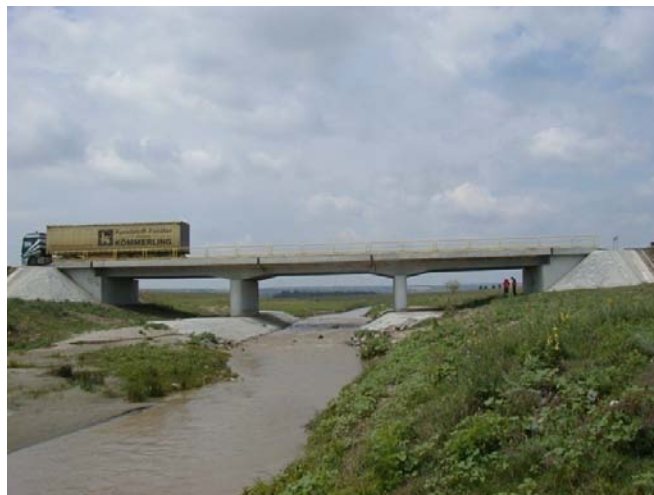
Photo. 1 Bridge over Berheci river, at Berheci (constructed in 1960/rehabilitated in 2002)

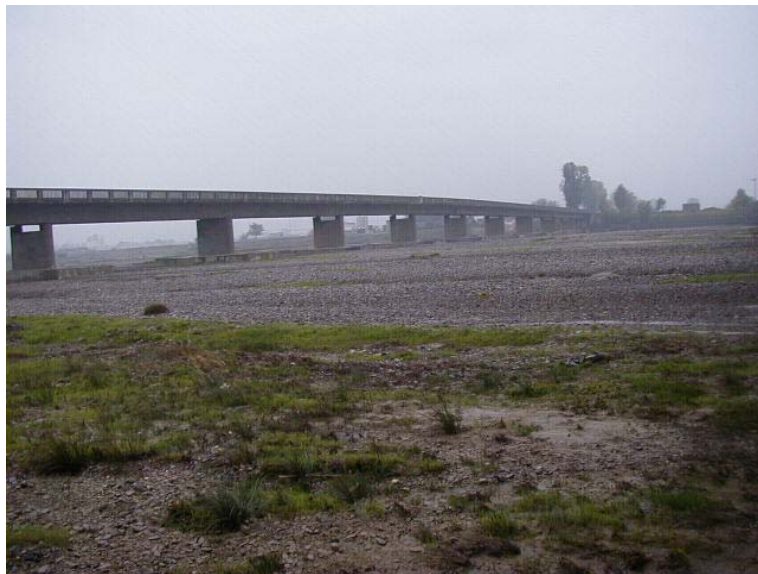
Photo.2 Bridge over Moldova river, at Timișești (constructed in 1961)

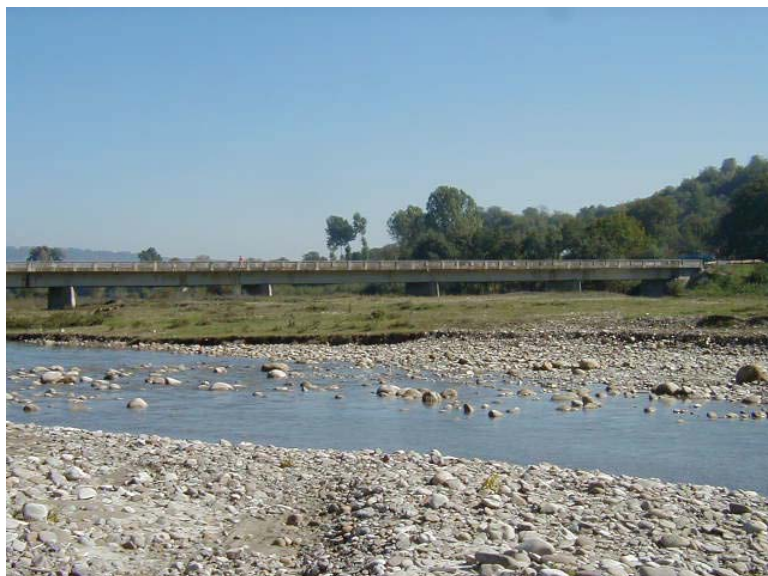
Photo.3 Bridge over Putna river, at Vidra (constructed in 1965)

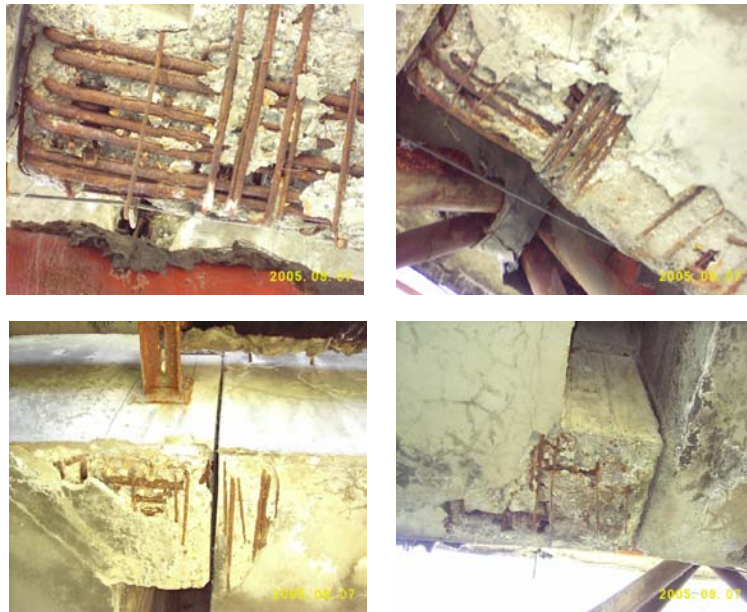
The degradation state from the bearing areas of the independent decks for some of the bridges mentioned above is depicted in the following images.

Photo.4 Bridge over Bistrița river, at Bacău

While steel bridges with hinged beams had a good reaction in time, most concrete bridges constructed in the same way had degradations in the hinges area, from which the following should be mentioned: concrete and reinforcement corrosion, concrete exfoliation, cracks, crevices etc.

These degradations were a result of the fact that the expansion joints covering devices between the main and secondary beams failed to ensure tightness against water infiltration from the carriageway and were aggravated over time, repair of these areas being almost impossible due to difficult access.

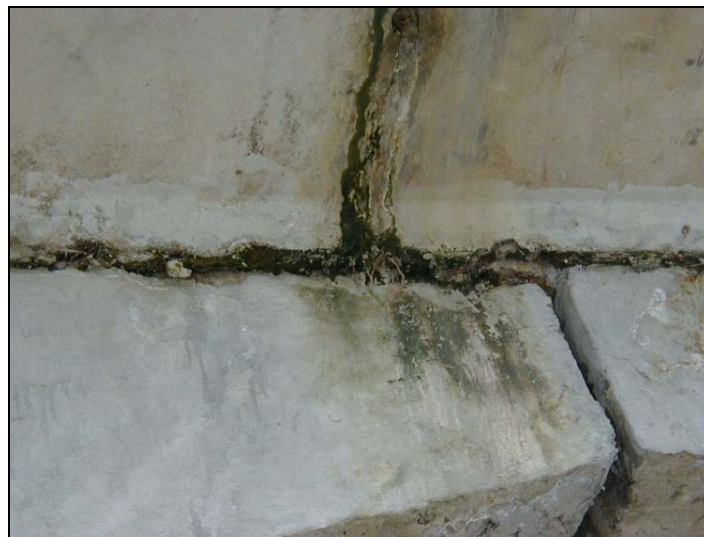
Photo.5 Bridge over Berheci river, at Berheci

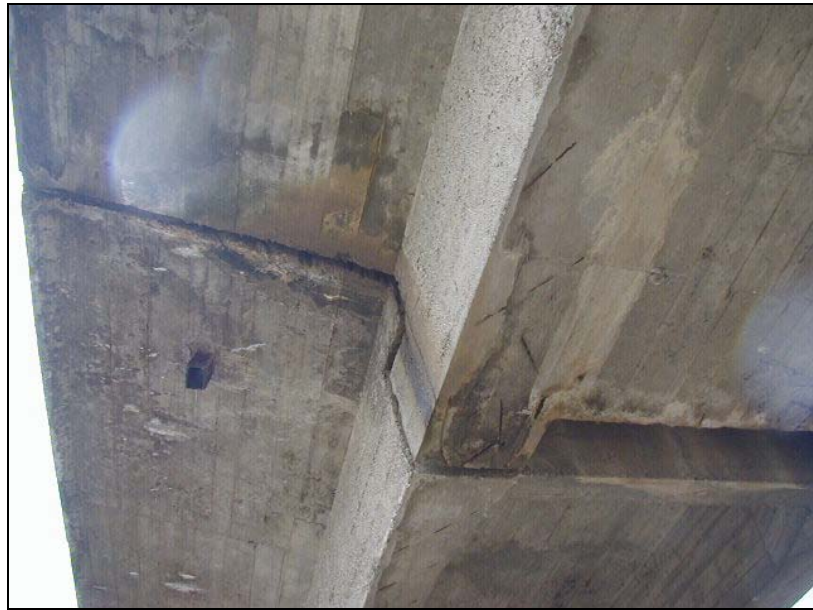
Photo.6 Bridge over Moldova river, at Timișești

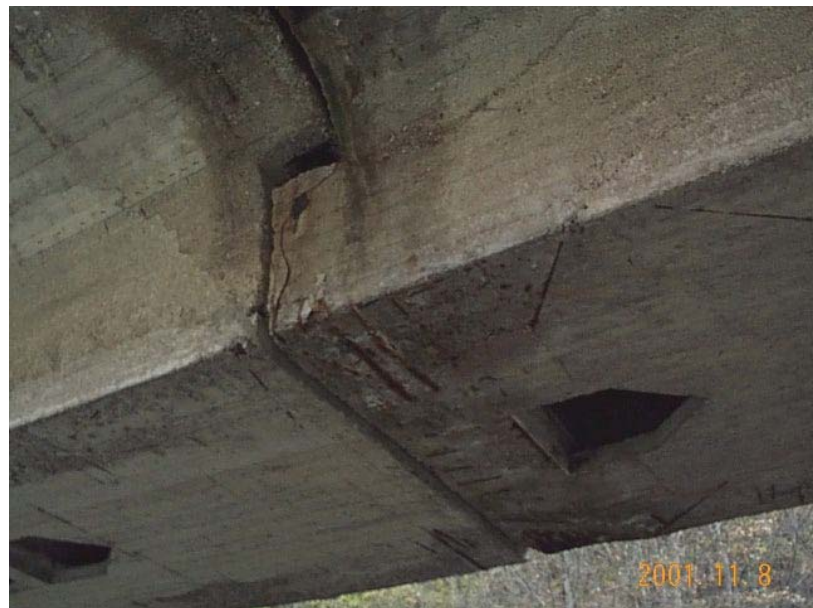
Photo.11 Bridge over Oituz river, at Oituz

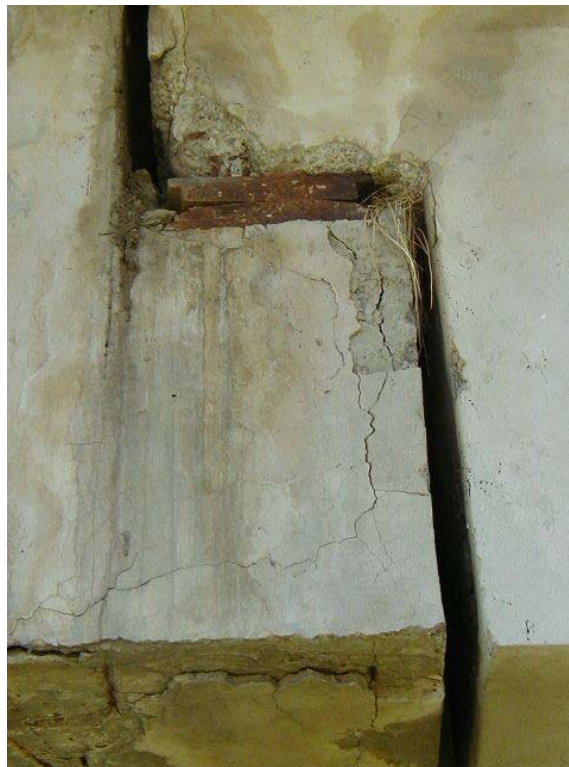
Photo.12 Bridge over Putna river, at Vidra

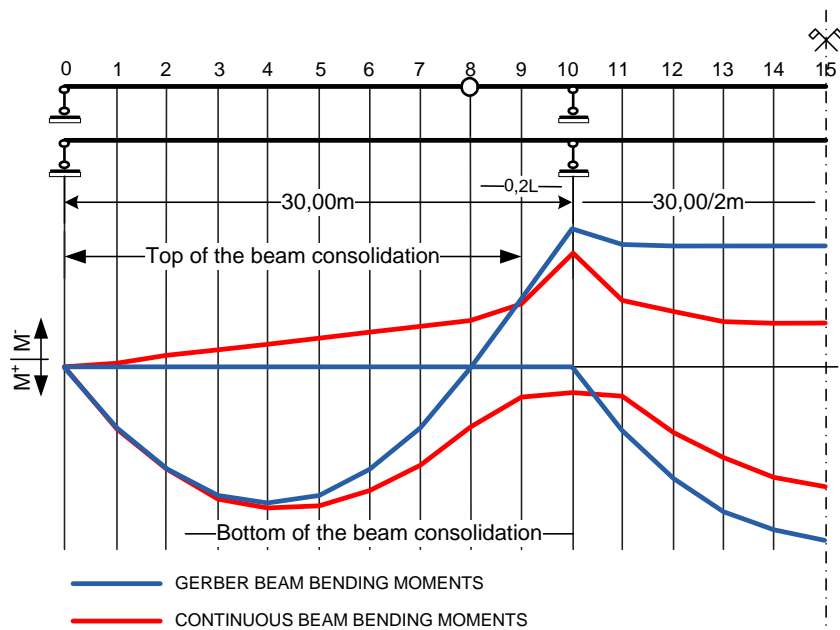
The superimposing of the two bending moment diagram, fig. 5, shows the beam areas which have to be consolidated, in order to increase the bearing capacity, by using one of the procedures described in chapter 2.

Fig.5 Identifying the beam areas whose section needs to be consolidated

The analysis of the two bending moments distribution diagrams, fig 5, shows that the beam needs to be consolidated in the marginal span at the upper level on the length between 0 ÷ 9 sections, and at the level of the lower foot on the length between 2 ÷ 11 sections, on the other areas the bending moments in continuous beam hypothesis have lower values than those for the Gerber beam.
