Numerical analysis of historical constructions

The paper addresses the scope of numerical analysis of ancient masonry structures. The numerical modelling intends to assess the stability conditions of the salient elements of the façade of the Cathedral of Porto dated from the middle of 12th century. Although no important visible cracking is present, the deep decay of the granite stone and corrosion of steel bars that connect the stone pieces can induce stability problems of the local salient elements of the façade. The numerical modelling is performed with the help of a commercial finite element software program DIANA.

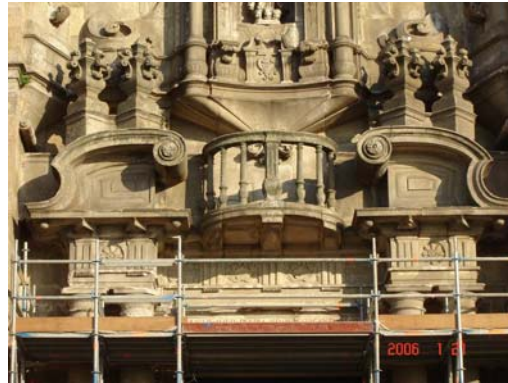
The central façade is composed of several salient elements, namely a central balcony and two lateral pinnacles, see Figure 1. The advanced degradation state of the granite of the columns below the referred structures led to the positioning of an auxiliary structure in order to avoid injury of people. This problem represented the main reason for the need of assessment the stability conditions of the main salient structural elements of the façade: the balcony and the pinnacles.

Figure 1. View of the two salient elements from the central part of the main façade of the Cathedral

Even so, considering the deep degradation of the granite, it is recommended a surface treatment of the stone, consisting in cleaning the superficial layer and water-proofing the granite surface, so that the polluting factors not to have access to the structure of the stone.

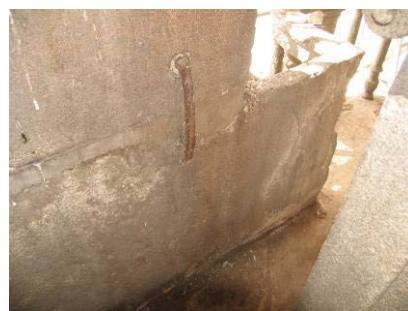
Figure 6. Left battlement of the facade

In the left side battlement four tests (two horizontal and other two vertical) were performed. The existence of two steel salient elements that connect two granite independent ashlar made impossible the radar inspection in that respective influence area. Even so, neither deficiency nor steel connectors were detected in this zone, see Figures 10, 11.

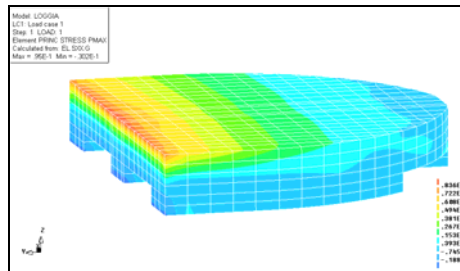
From the normal stress distribution, it is observed that the maximum values appear at the support's section, where maximum bending moments occur. It is noted that in fact the structure behaves as a cantilever.

Figure 15. Syy stress distribution

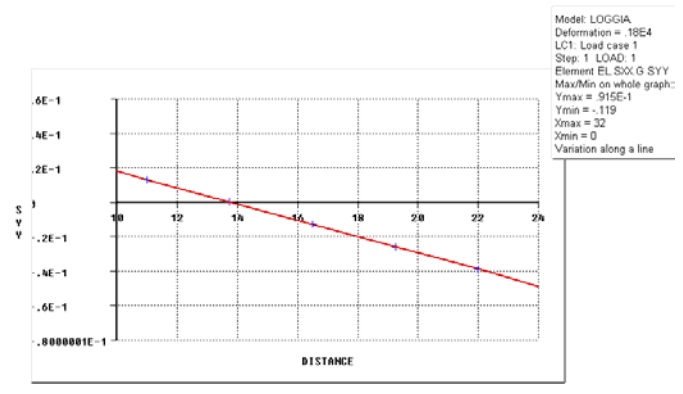
As expected, the normal stress diagram along a cross section defined at the support is linear, see Figure 19. Tensile stresses occur at the upper part of the section, whereas the maximum normal compressive stresses occur at the lower fibre.

Figure 19. Stress diagram in the critical section

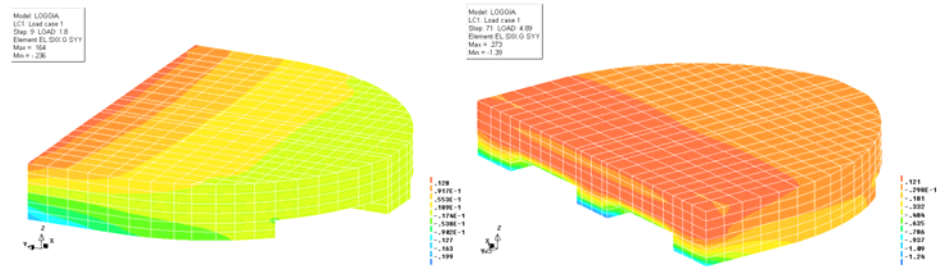
The relation between the load factor and the maximum vertical displacement obtained at the border of the balcony is shown in Figure 26. The onset of the nonlinear behaviour occurs for a load factor of about 1.8, being the cracking localized in the upper edge of the support's section, see Figure 27 and Figure 28, where the principal stress and strain distributions associated to cracking are displayed. For the tensile strength of granite, the load factor is 4.8. This factor represents the scalar that multiplies the gravity load, indicating the safety level of the structure. Note also that the vertical displacement (2.5mm) is rather reduced. This state corresponds to tensile and compressive maximum stresses of respectively 2.79 and 14.6 MPa. It is important to stress that the compressive stress obtained in the nonlinear analysis is clearly below the compressive strength adopted for the granite, which means that the linear model under compression is valid, see Figure 29. Given the weathered state of the granite, an additional nonlinear analysis was performed considering a tensile strength of granite of about 0.5MPa and a fracture energy of about 0.078N/mm, (corresponding approximately to safety partial coefficient for the material γ_M of 3.0). As expected, the initial behaviour is similar but a considerably lower load factor of 1.8 is obtained, see Figure 26. This means that considering 1/3 of the tensile strength, a load factor 80% higher than the own weight is still achieved. For this situation, the maximum values of the tensile and compressive stress are respectively 0.85MPa and 5.33 MPa.

Figure 27. S_{yy} stress distribution for the first crack stage and for the failure stage of the balcony

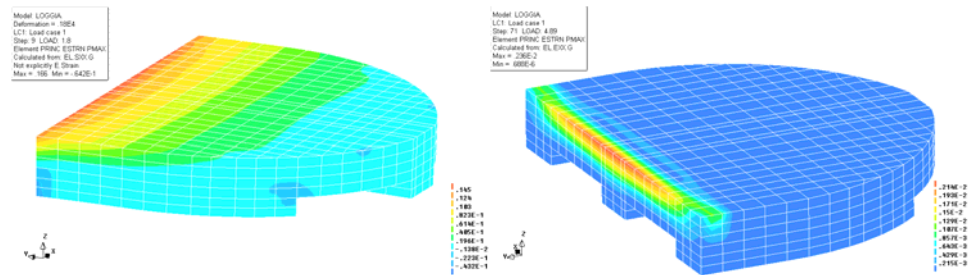
Figure 28. Maximum principal strains for the first crack stage and for the failure stage of the balcony

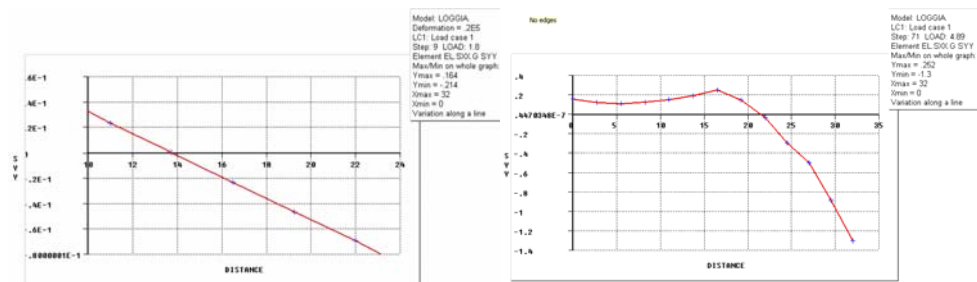
The normal stress distribution at the support's section that crosses the central rib corresponding to the collapse state obtained with $f_i=1.56\text{MPa}$ is shown in Figure 30. It is observed that there is possibility of tensile stress transfer in the upper fibre.

Figure 30: Stress diagram in the critical section for the first crack stage and for the failure stage for the balcony

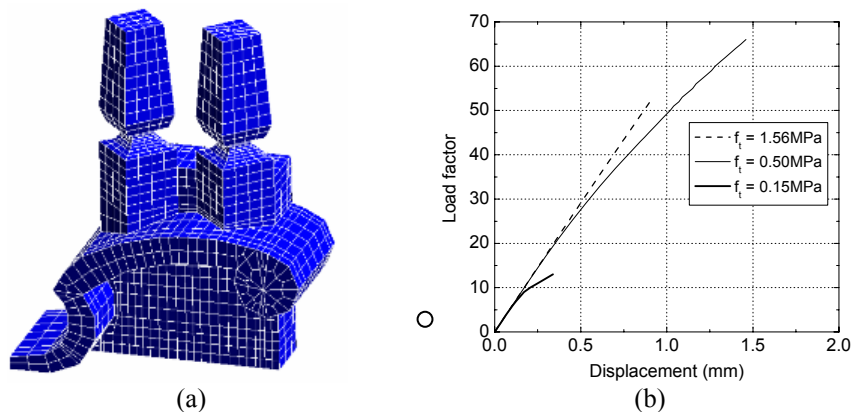
The relation obtained between the load factor and the control displacement based on the tensile strength of granite of 1.56MPa is displayed in Figure 31. An additional nonlinear analysis based on a tensile strength of 0.5MPa was also carried for the pinnacles. It can be seen that the response of the pinnacles exhibits reduced nonlinearity when the tensile strength of 1.56MPa is considered, see Figure 31. The high load factor found for both conditions results from the lower level of stresses associated to the own weight.

Figure 31. – Results of the nonlinear analysis of the pinnacles; (a) vertical control displacement; (b) relation between the load factor and the displacement control
