Robot helps us to rehabilitate an Over Pass in Resita

Summary

In the winter of 2007 an over gauged transport has heavily hit the three monolith reinforced concrete girders of the superstructure.

The paper presents the damages of the superstructure and also the rehabilitation solutions, which involve the adjustment of the geometry of the under passing junction arm as well.

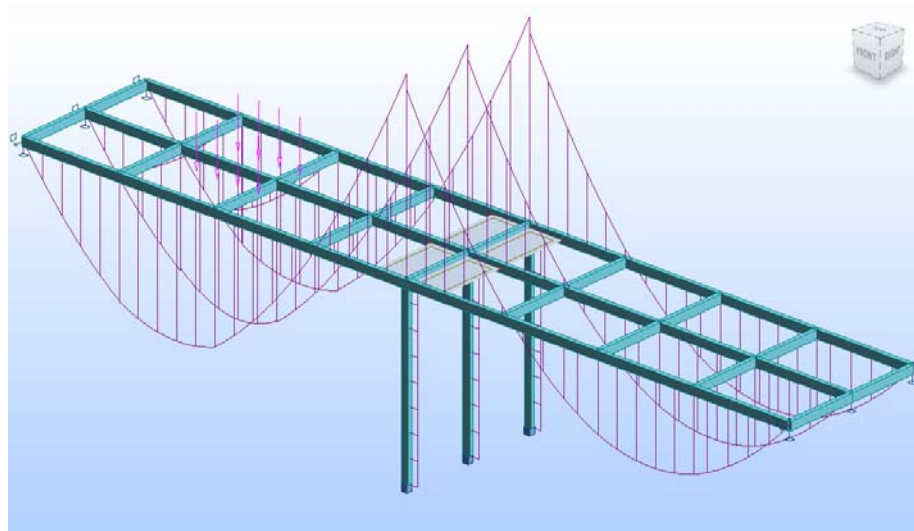
Figure 8. Bending moment from permanent load + V80 convoy

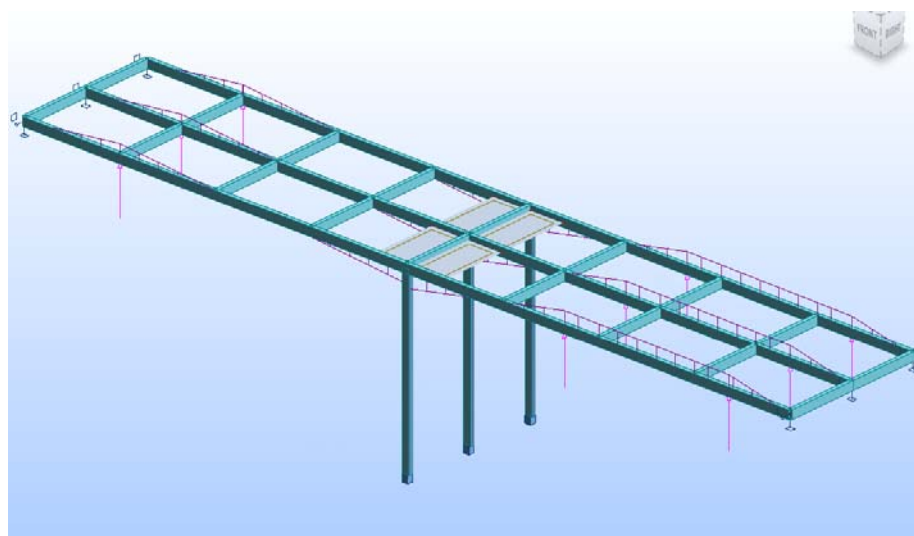
The principle of superpositioning the effects made possible to find a load combination in the 3 supporting lines with jacks, which lead to a minimal load value in the degraded area and to acceptable values in the other characteristic sections (lower than the loads the structure was designed at) (Fig. 9 and 10).

Figure 9. Bending moment from additionally loading from the hydraulic jacks

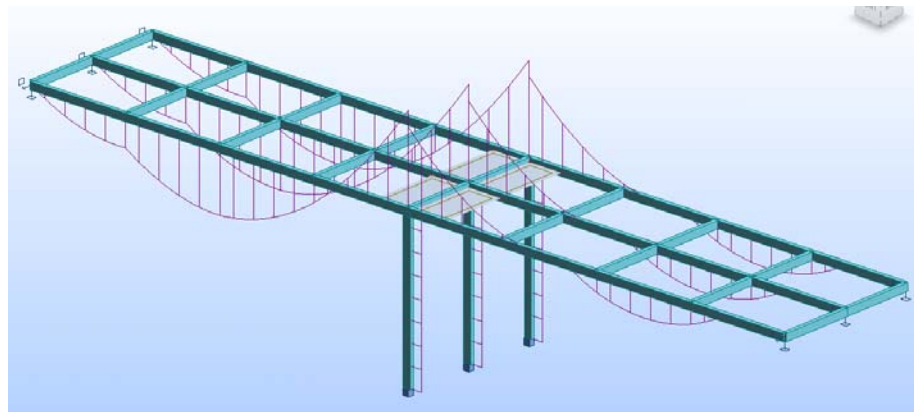
Figure 10. Bending moment from additionally loading from the hydraulic jacks and permanent load

Thus the replacing works of the degraded reinforcement can be carried out at 23% of the load afferent the permanent loading (Fig. 11).
